Feasibility  
(Section 1135) Report  
and  
Environmental Assessment

# Fish Passage Modification Charles River Dam Boston, Massachusetts

December 1992

US Army Corps  
of Engineers  
New England Division

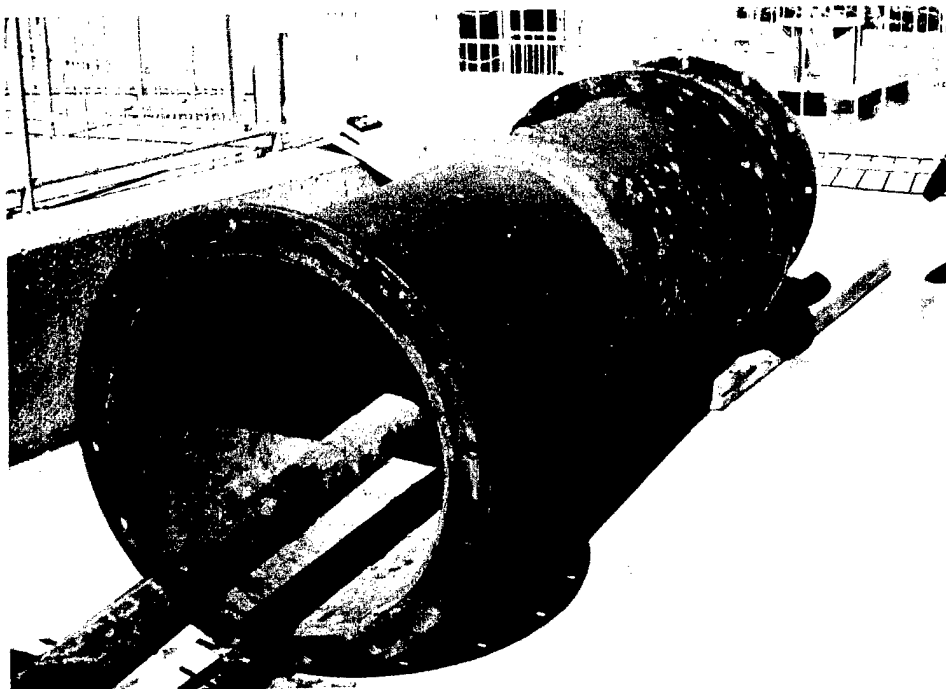
FIGURE 1. Fishway pump outer casing and shaft enclosing tube.

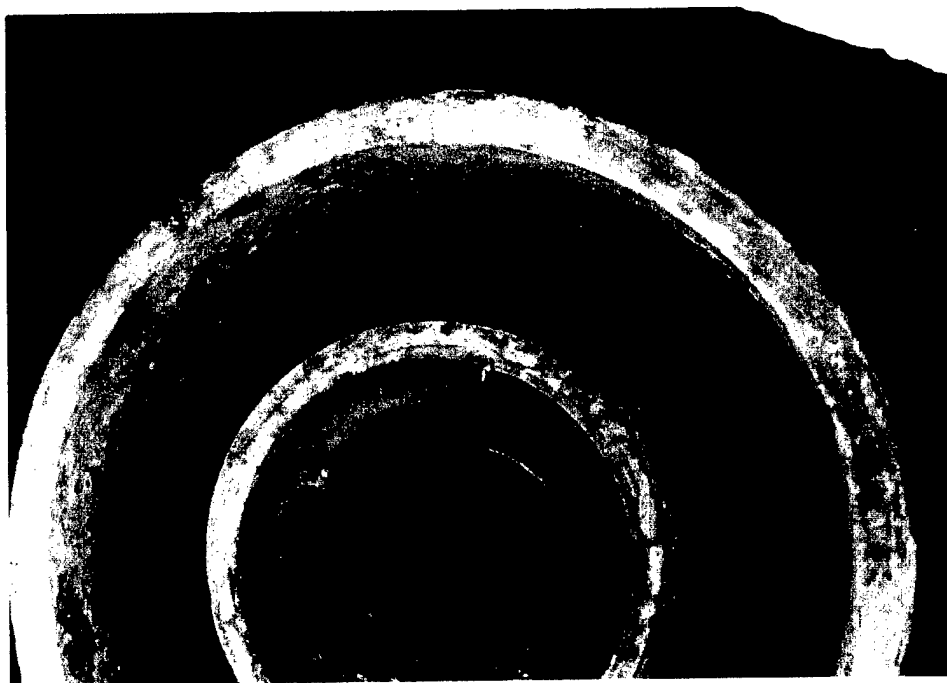
FIGURE 4. Fishway pump suction bell & lower bearing support.

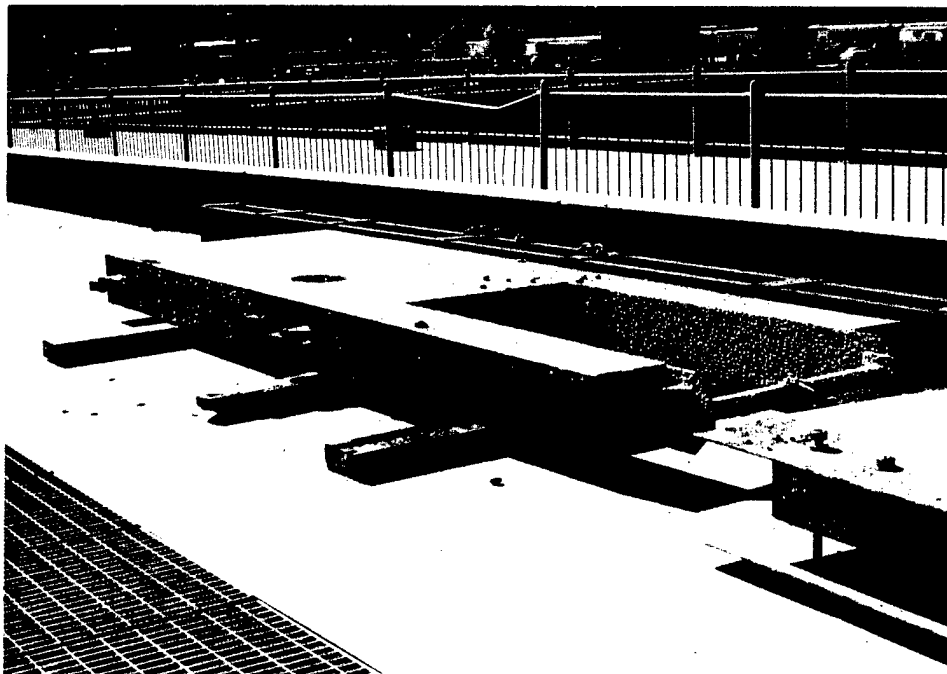
FIGURE 6. Floating weir, upper section.

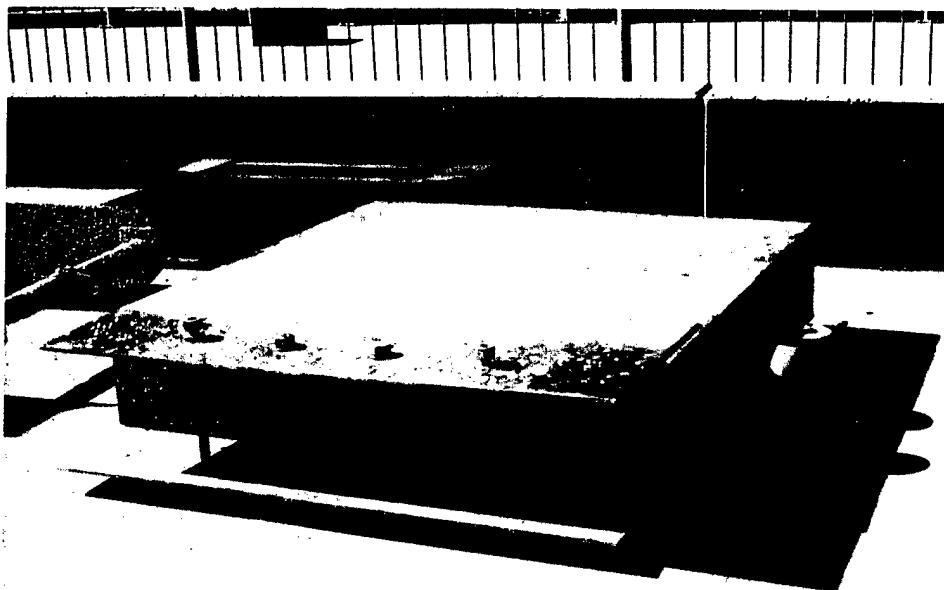
FIGURE 7. Floating weir, lower section.
